A World of Change

*1st Annual
AAR Research Review
November 6-9, 1995*

VOLUME 1: FAST/HAL TEST SUMMARIES

*Association of American Railroads
Transportation Technology Center
Pueblo, Colorado*

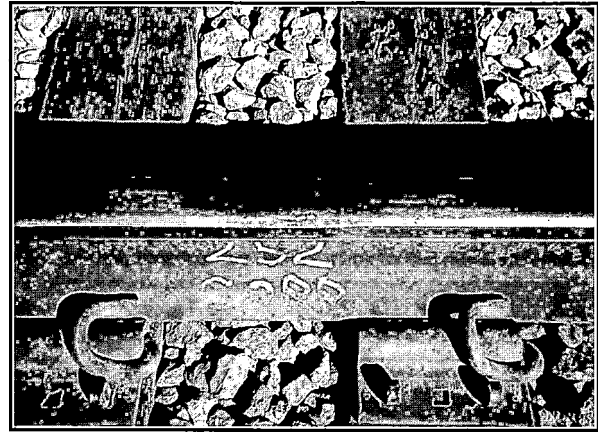
Figure 5. Surface Fatigue Defect

Not only was the standard rail the only one to crush, it was the only rail to corrugate. Corrugations were observed in the control rail at 15 MGT with wavelengths from 12 to 18 inches. Measurements collected at 21.8, 67.0, and 84.6 MGT, illustrated in Figure 4, depict how the corrugations grew with tonnage. By 84.6 MGT, corrugations were as deep as 0.11 inch. None of the head hardened rails had developed visible corrugations during the 84.6 MGT test period. Vertical force measurements collected on corrugated rail under 125-ton cars were as high as 95 kips in the trough of .070-inch corrugations. Figure 5 illustrates a surface fatigue defect (deep spall) typical of many that developed in the troughs of the corrugations, likely in part due to high dynamic vertical forces.

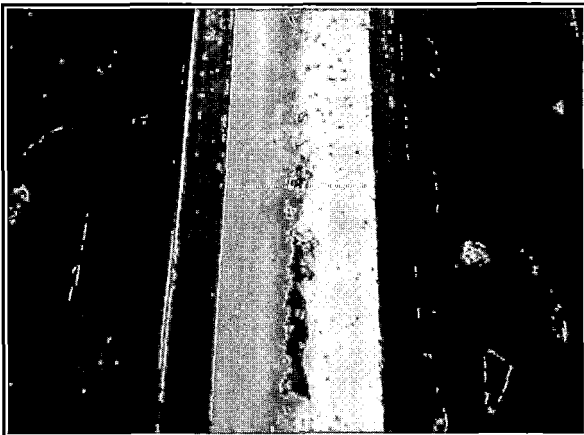
Figure 8. Spalling of Section 03 Low Rail in the Wood Tie Zone after 50 MGT

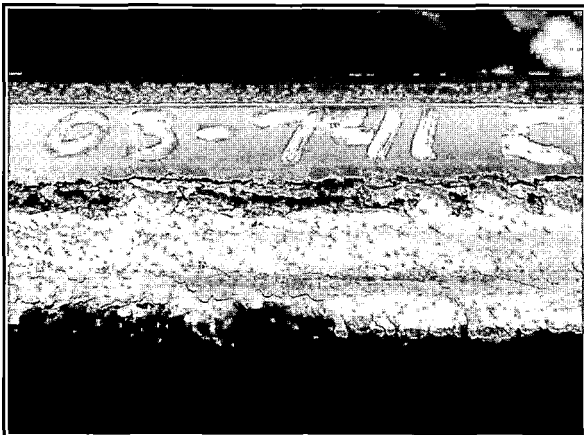
Figure 9. Close-Up View of Spalling in the Wood Tie Zone showing Metal Flow to the Field Side

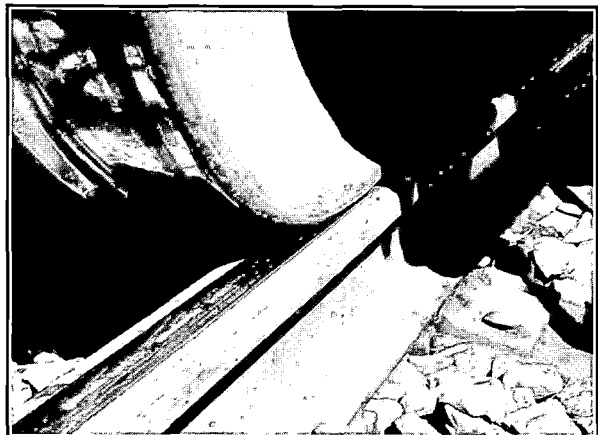
The heavy spalling in the Passive Zone of Section 25 appeared quite differently from that in Section 03. These spalls are located to the gage side of the low rail (which has an 8-inch crown radius) at the edge of wheel/rail contact. Reconstituted ties with cut spikes were originally in track in this area and have since been replaced by Pandrol fasteners and woodties. The reconstituted ties exhibited field side tie plate cutting and wide gage before being removed. Tie plate cutting likely rotated the low rail out and forced contact to the gage side of the rail and resulted in the spalling.

Figure 10. Rim Edge of a Passing Wheel Contacting Center of Low Railhead at Spalling Location (due to wide gage)

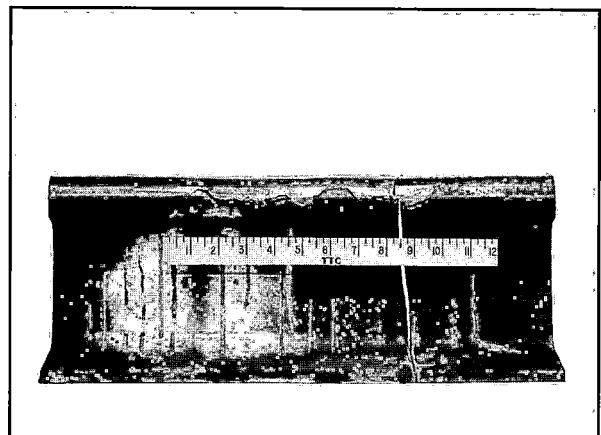
Standard chemistry 300 Bhn ingot rail has been installed in previous HAL tests at FAST in both Sections 25 and 3. These tests were conducted with the standard FAST heavy axle load train. Within 200 MGT, this rail had produced numerous shell defects, one of which is shown in Figure 13. Some of these shells turned down, as did the shell shown in Figure 13, into detail fractures (shown in Figure 14). Nearly all non-head hardened rails installed in the fatigue test curves at FAST eventually developed defects of the types shown. Head hardened rails have been much more resistant to these defects, some withstanding several hundred MGT and being removed with no defects. FAST experience tell us that NKK rail in the current test will not likely develop internal fatigue defects within 400 MGT. It will be several years before the final fatigue results of this test will be available.

Figure 13. Shelling of Standard 300 Bhn Ingot Cast Rail under FAST HAL Testing

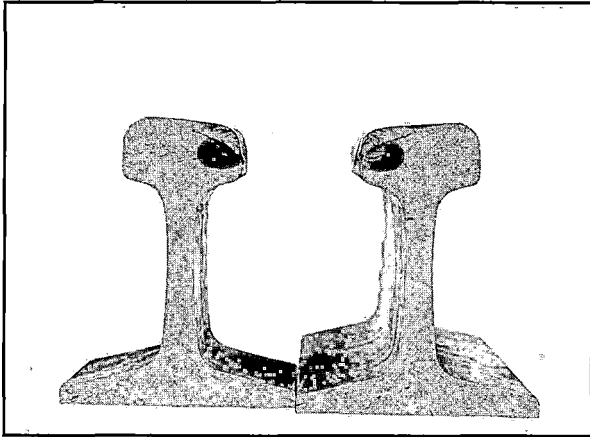
Figure 14. Detail Fracture Portion of the Shelling Defect Shown in Figure 13

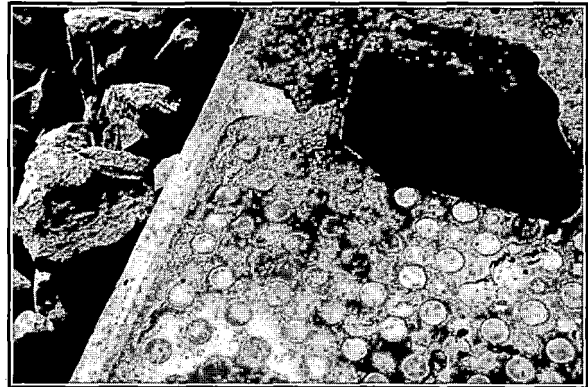
- High annual tonnage
- Moisture
- Severe curvature and high lateral/verticle conditions
- Heavy axle loads
- Rail grinding
- Sand (from locomotive and/or wind blown)

Figure 1. Appearance of Rail Seat Abrasion in the Field

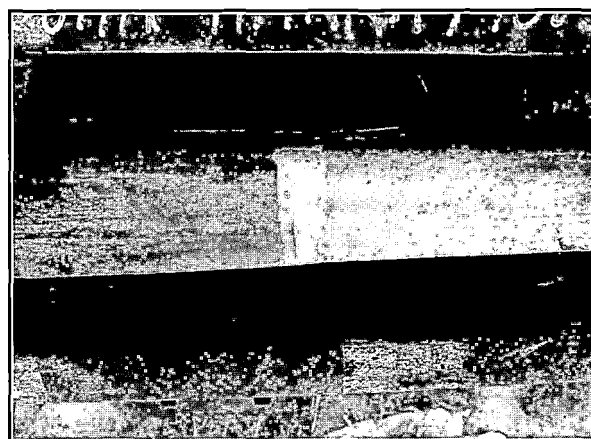
Figure 3. Crack in V-A Vario Frog

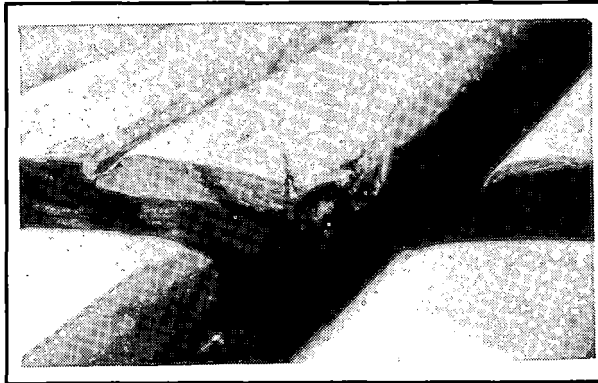
Figure 3. 62-Degree Crossing Rail End after 4.6 MGT of HAL Traffic

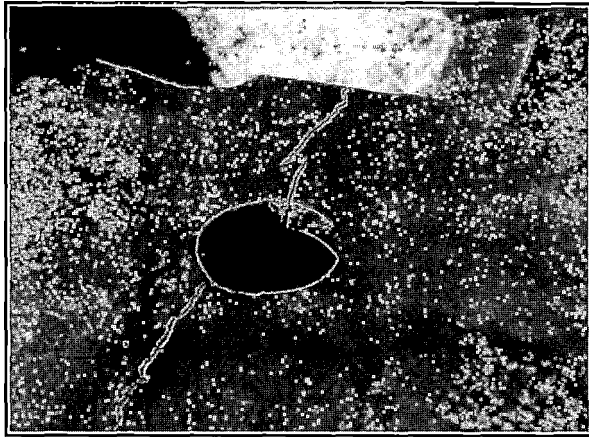
Figure 5. Crack in Casting of 76-Degree Crossing

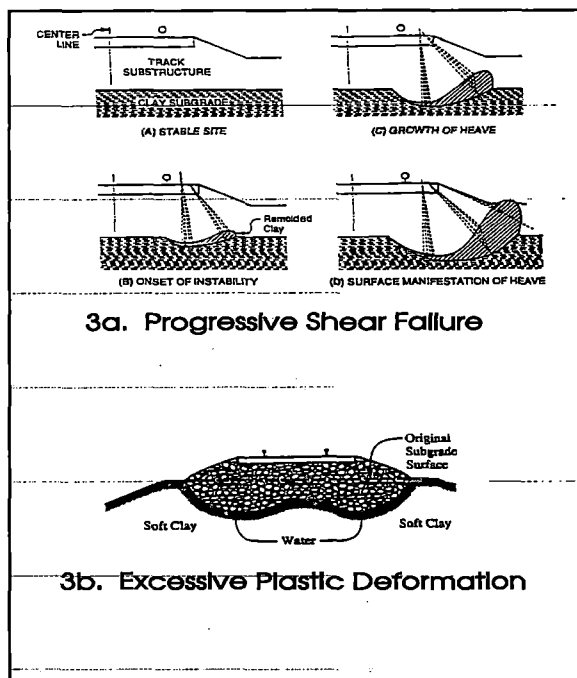
Figure 3a and 3b. "Soft" Subgrade Failure Modes
